Inspection Report

Sample Report

123 Main St
Anytown ME 04000

Square One Home Inspections LLC

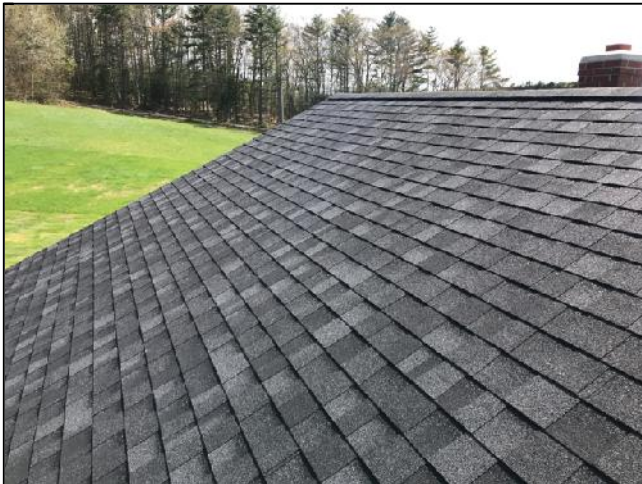
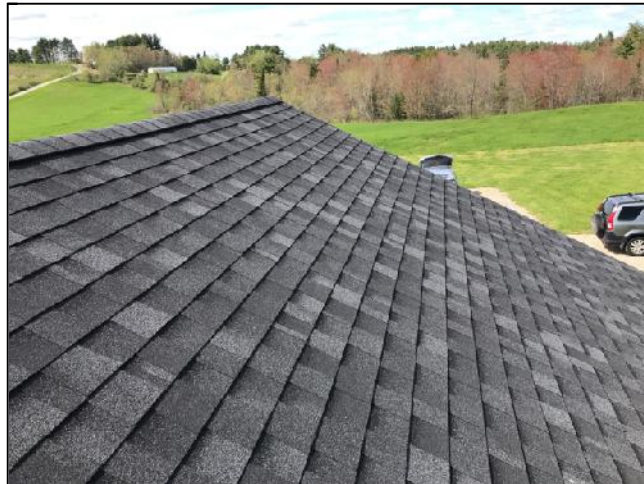
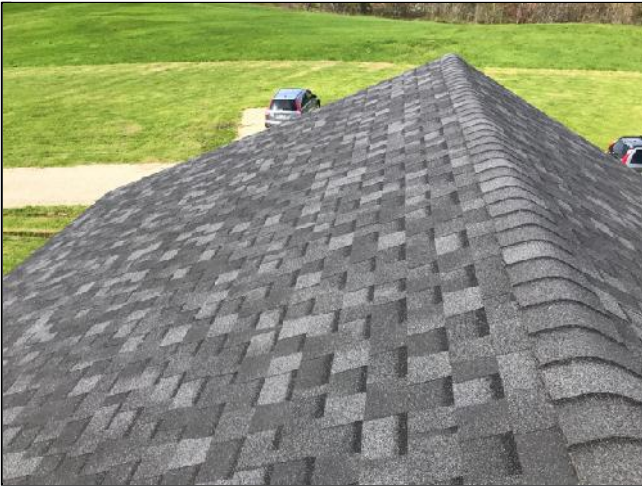
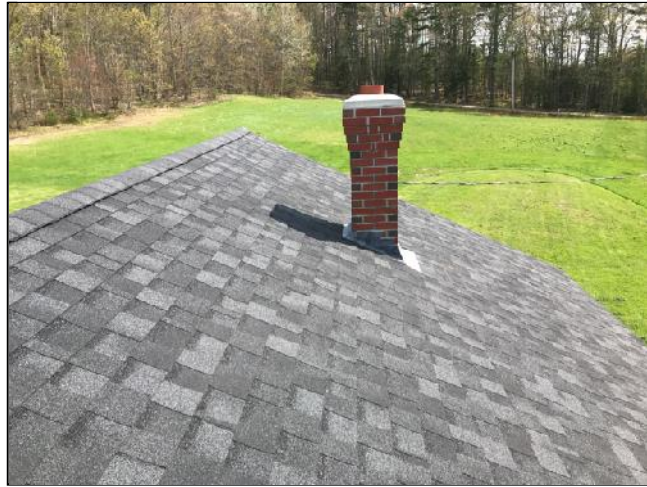
1.0 Architectural shingles

1.0 Item 1(Picture) Architectural shingles

1.0 Item 2(Picture) Architectural shingles

1.0 Item 3(Picture) Architectural shingles

1.0 Item 4(Picture) Architectural shingles

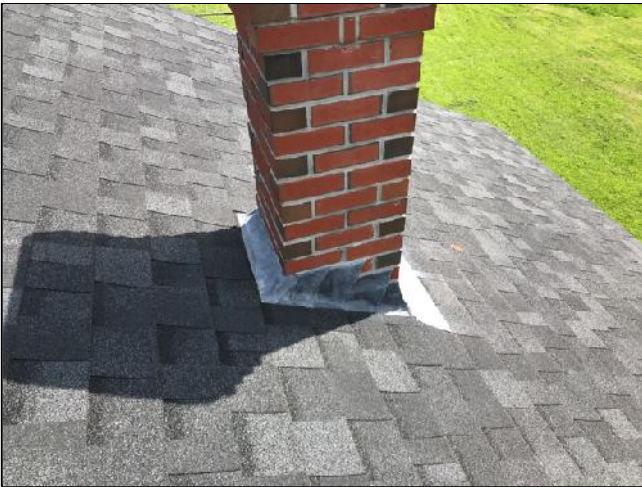
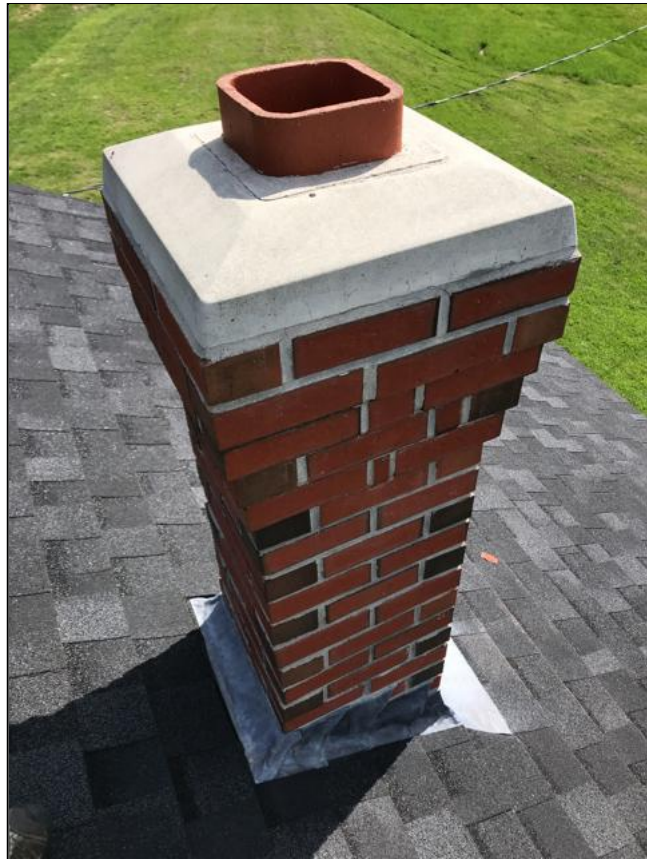
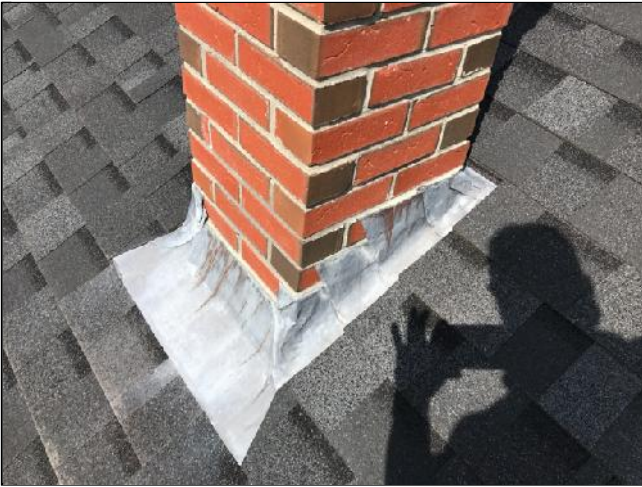
1.2 Lead flashing around chimney. Chimney cap is recommended to protect chimney and block rain/snow from entering chimney.

1.2 Item 1(Picture) Lead flashing around chimney

1.2 Item 2(Picture)

1.2 Item 3(Picture) Lead flashing around chimney

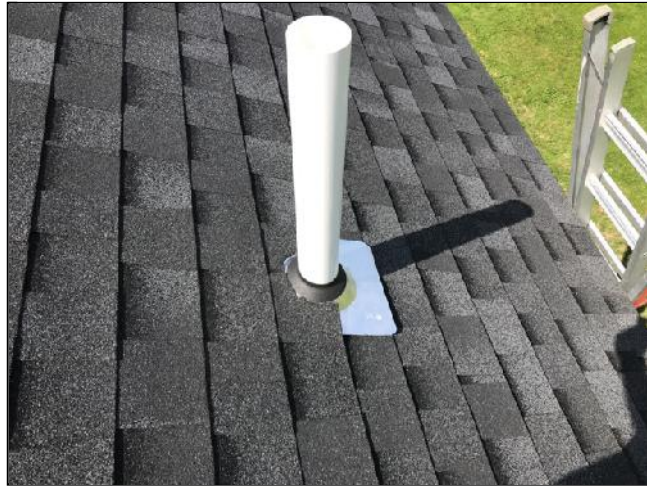
1.2 Item 4(Picture) Plumbing boot

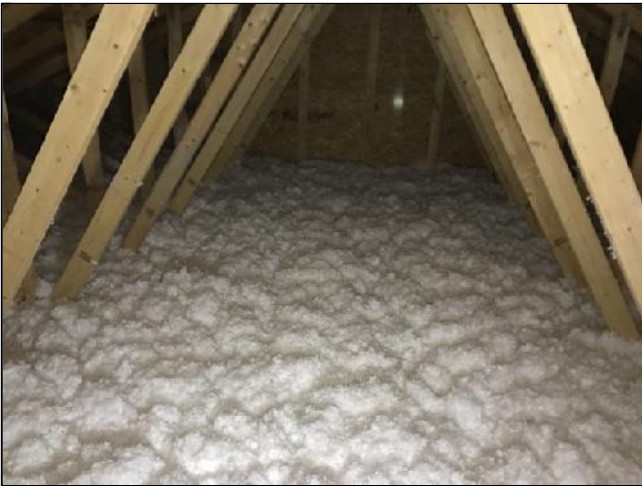
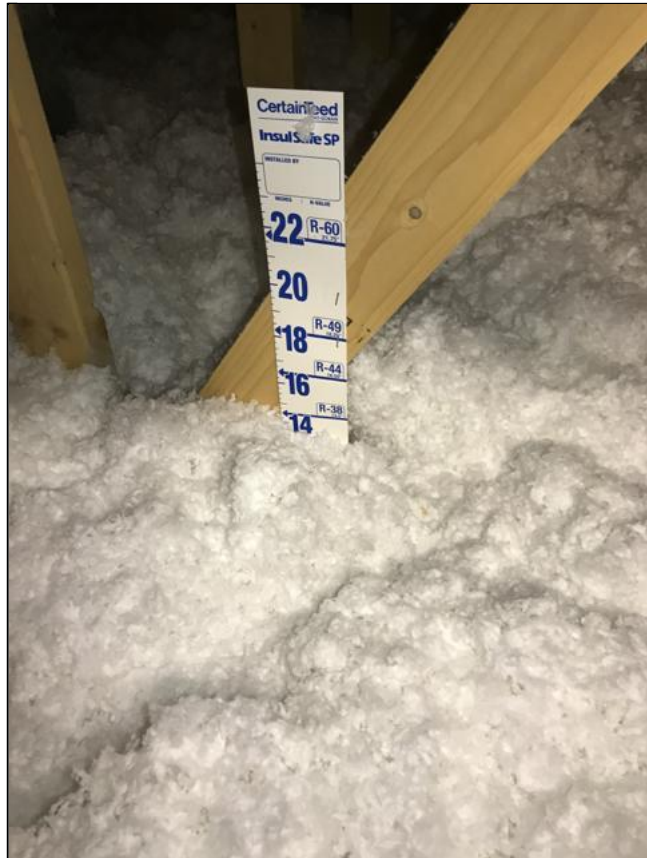
1.7 14-16" of insulation in attic

1.7 Item 1(Picture) Insulation in attic

1.7 Item 2(Picture) 14-16" of insulation in attic

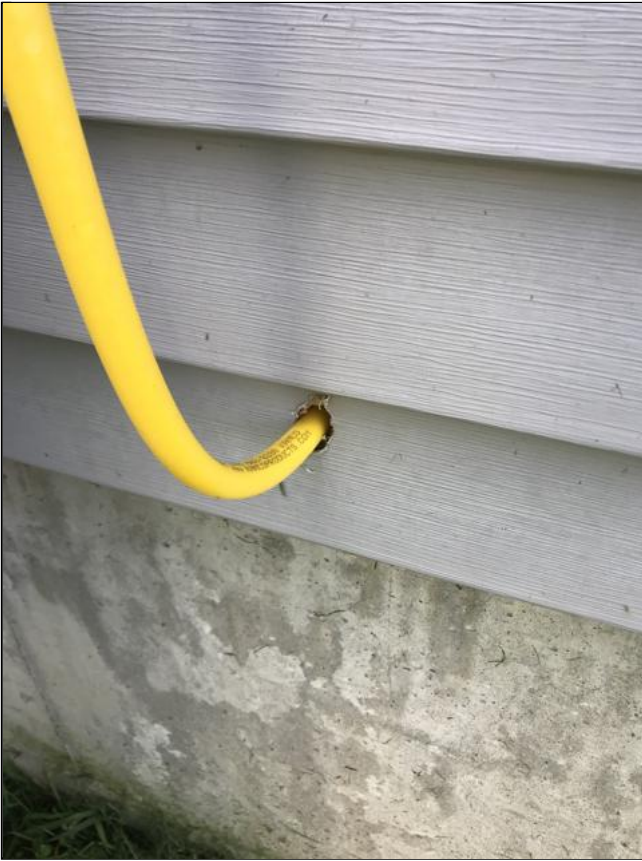
2.0 Caulking recommended around fuel entry to block water and pests from entering home

2.0 Item 1(Picture) Caulking recommended

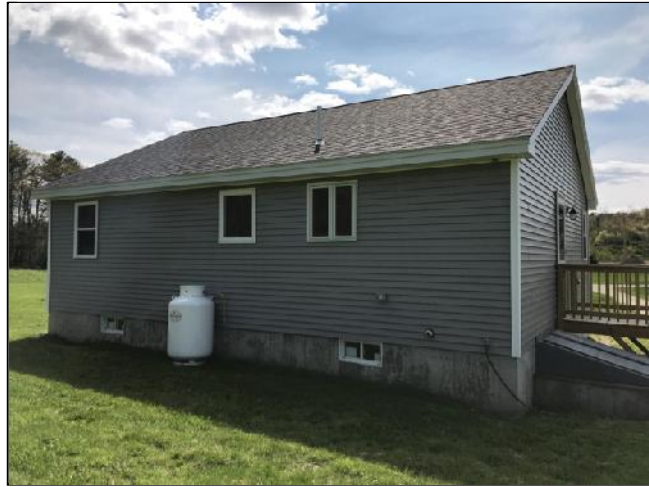
2.0 Item 2(Picture) Vinyl siding

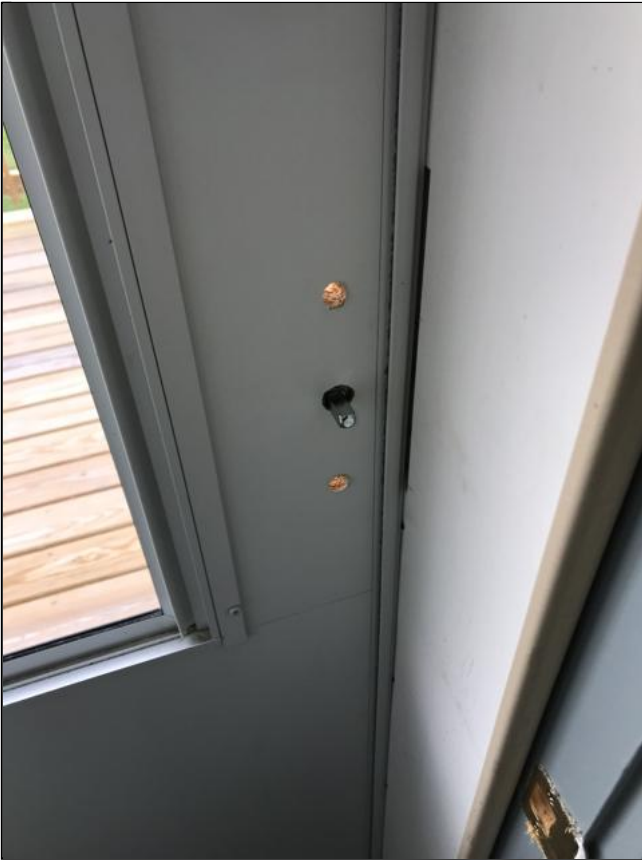
2.1 Door to deck is missing doorknob to enter/exit

2.1 Item 1(Picture) Door to deck is missing doorknob to enter/exit

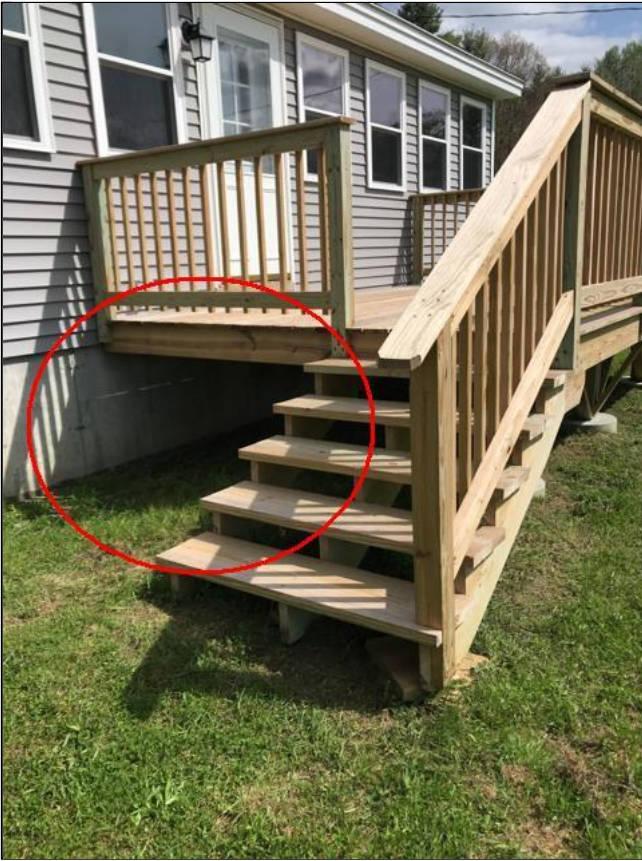
Deck guards are recommended to be added to left side of each staircase, for safety.

2.3 Item 1(Picture) Left side deck guard recommended

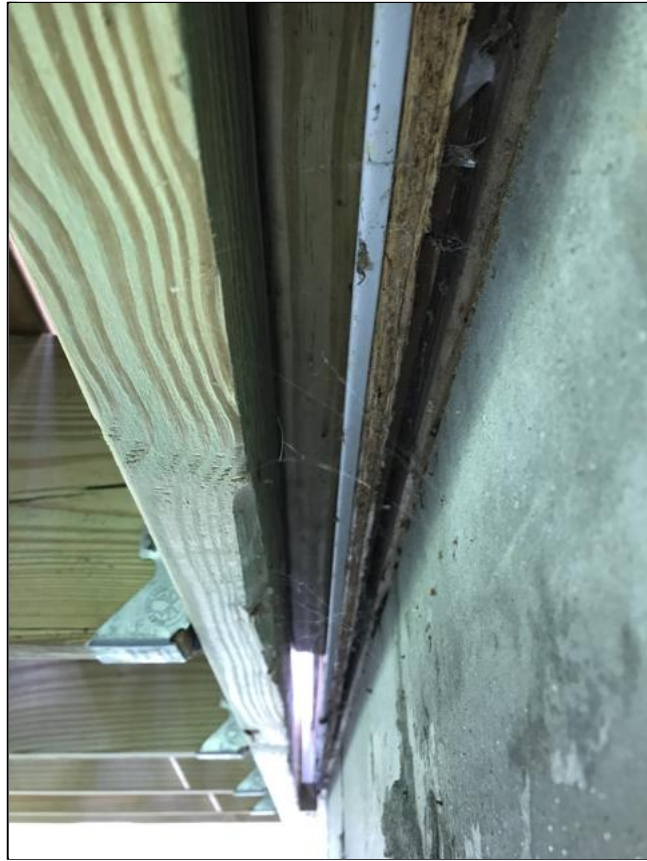
2.3 Item 2(Picture) Dry Sill

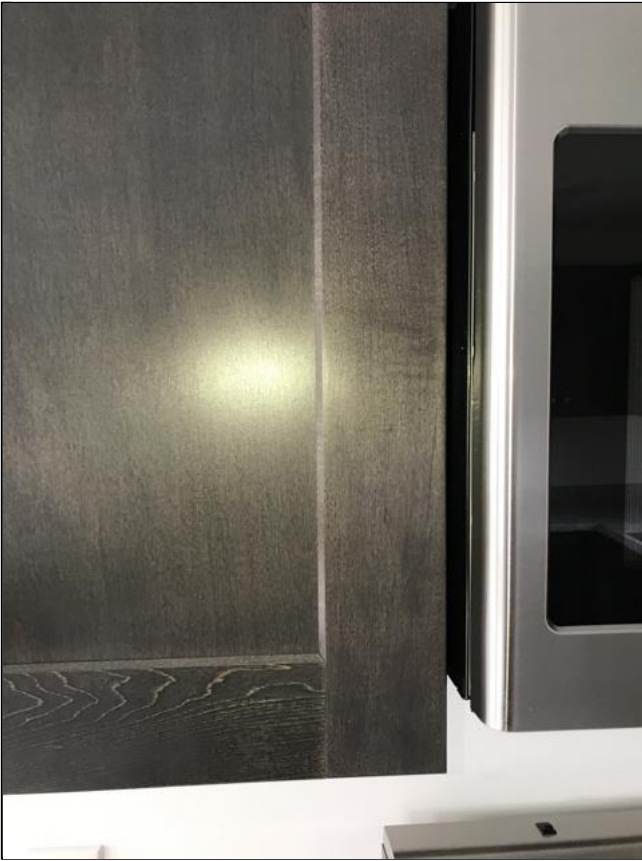
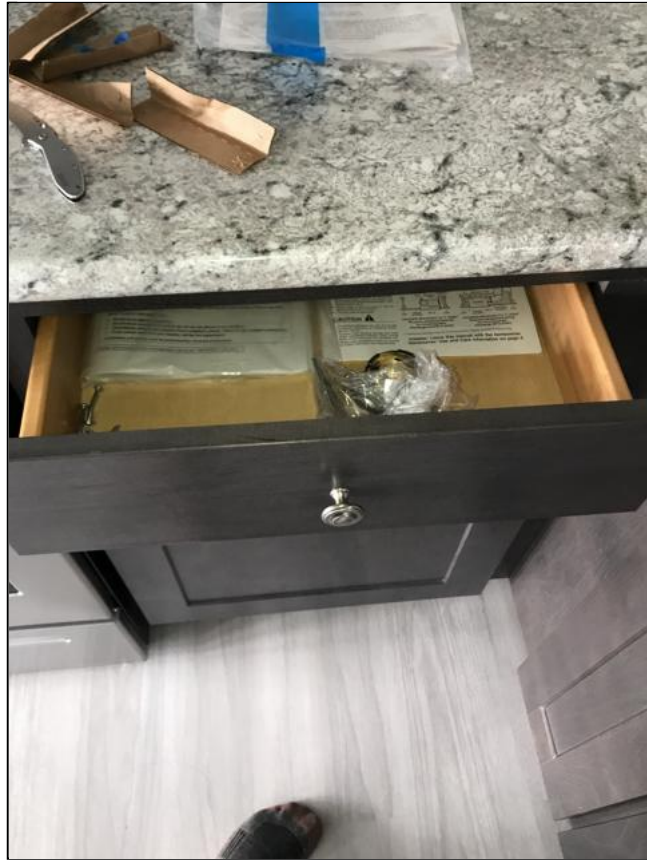
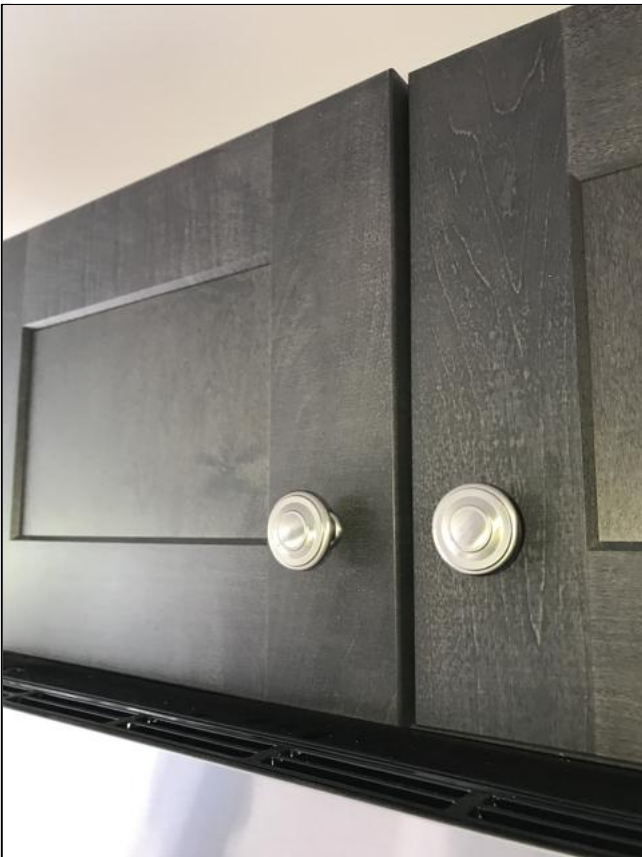
4.5 Kitchen cabinets require adjustments.

4.5 Item 1(Picture) Door rubs against microwave

4.5 Item 2(Picture) Drawer does not soft-close as intended

4.5 Item 3(Picture) Door does not close flush

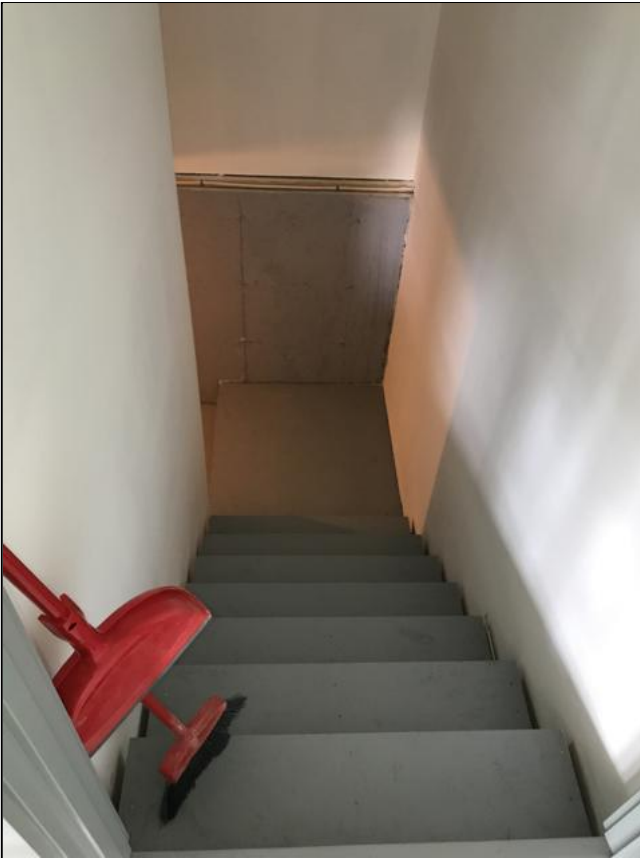
5.3 Railing required on at least one side of stairs

5.3 Item 1(Picture) Railing required on at least one side of stairs

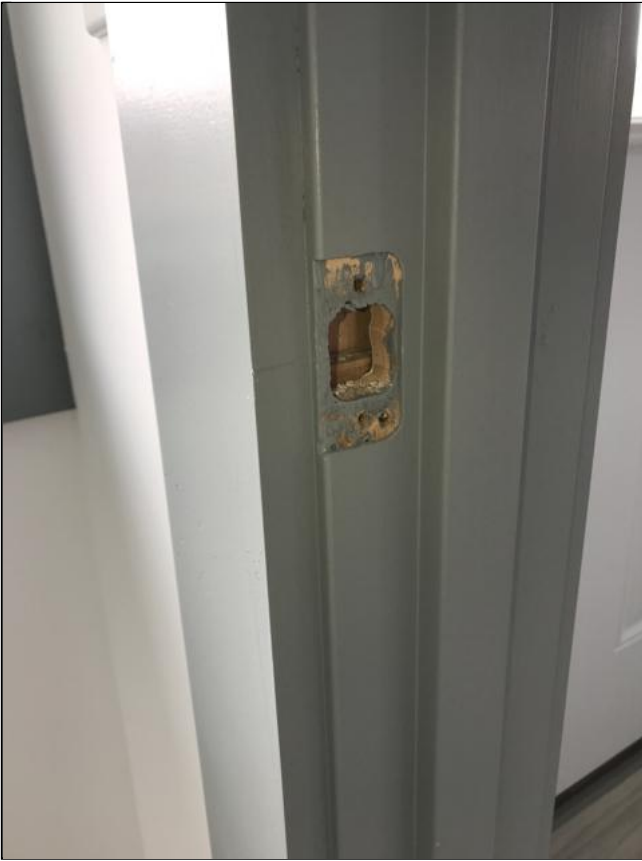
5.4 Door slide/guide is missing in front office/bedroom

5.4 Item 1(Picture) Door slide/guide is missing in front office/bedroom

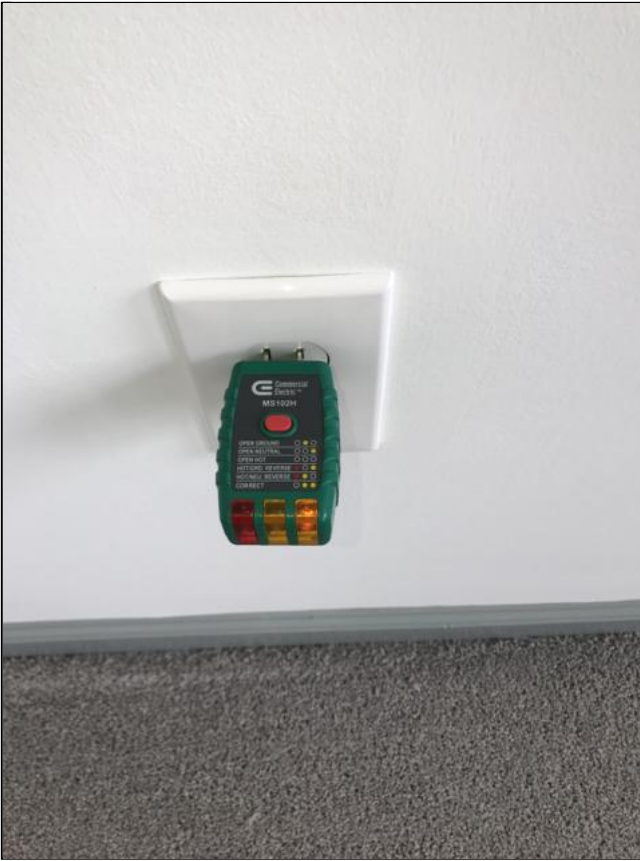
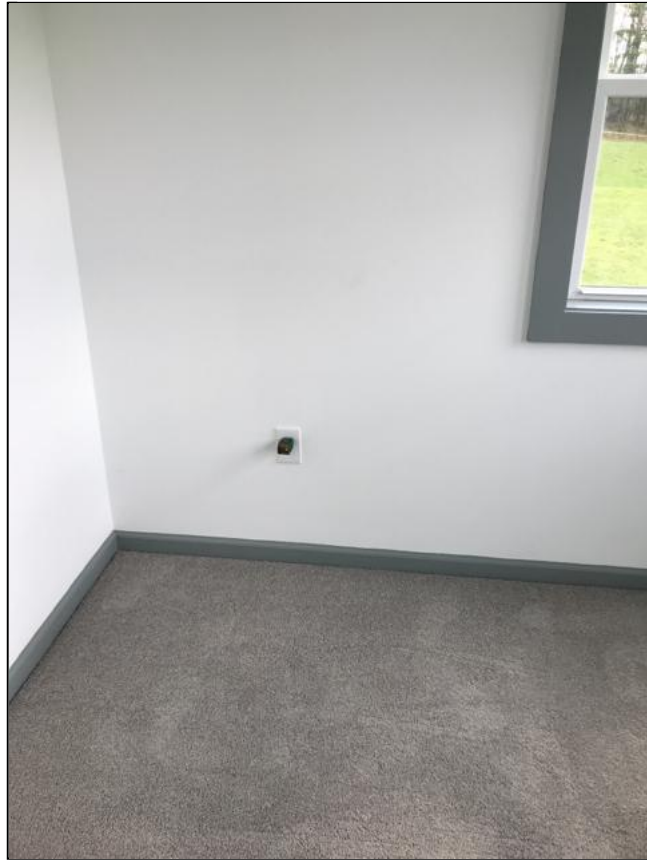
5.6 Front office/bedroom outlet incorrectly installed with an open neutral. Recommend to be re-installed by a qualified electrician.

5.6 Item 1(Picture) Receptacle incorrectly installed

5.6 Item 2(Picture) Receptacle incorrectly installed

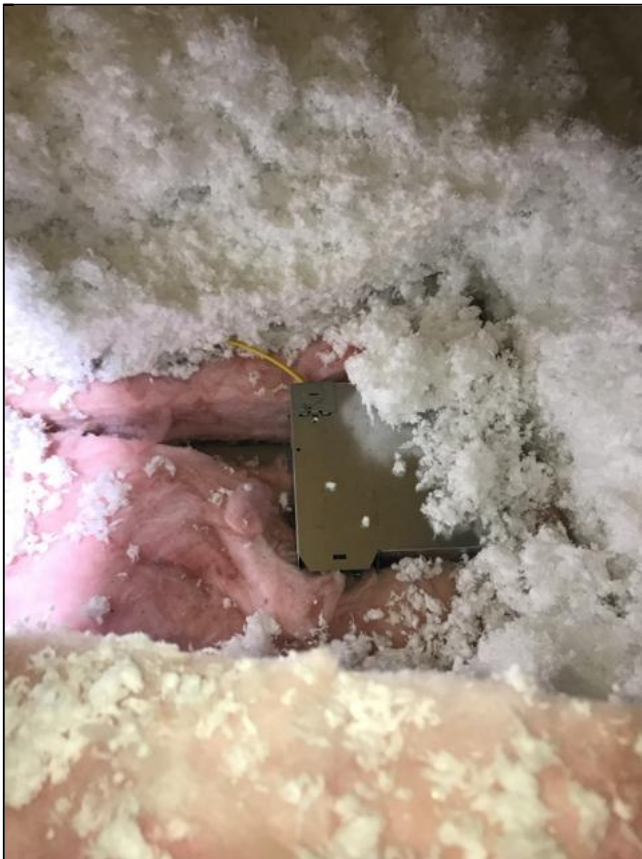
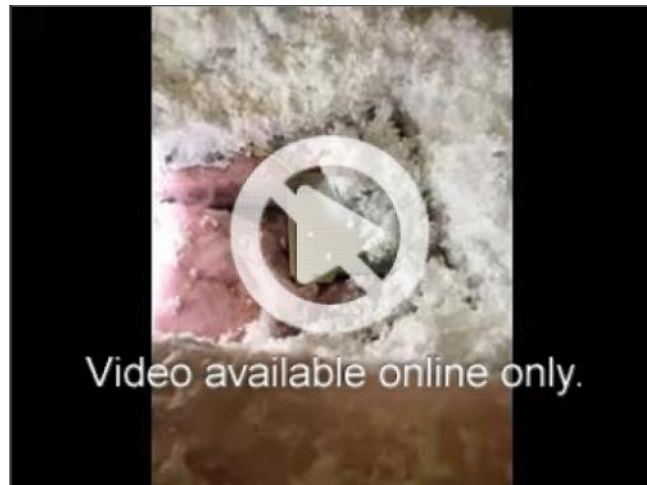
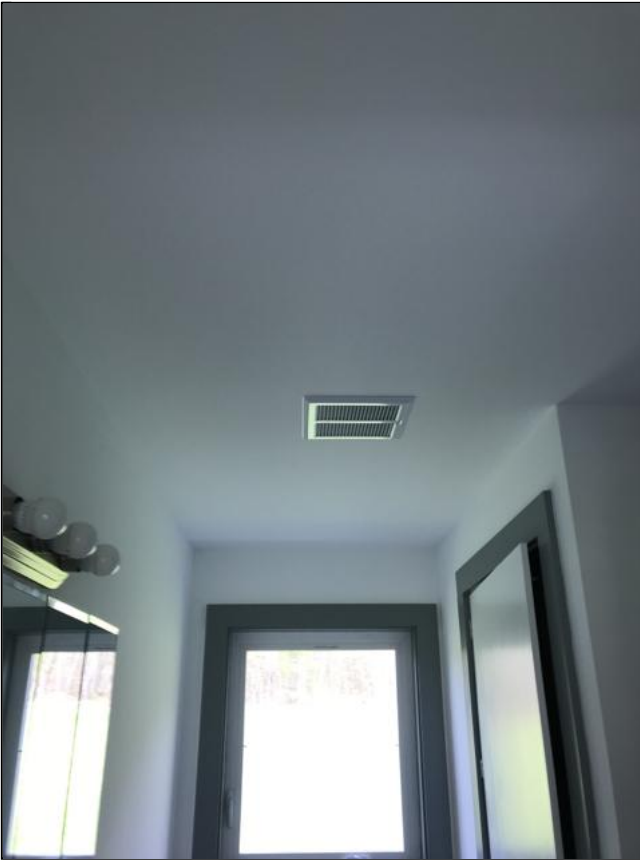
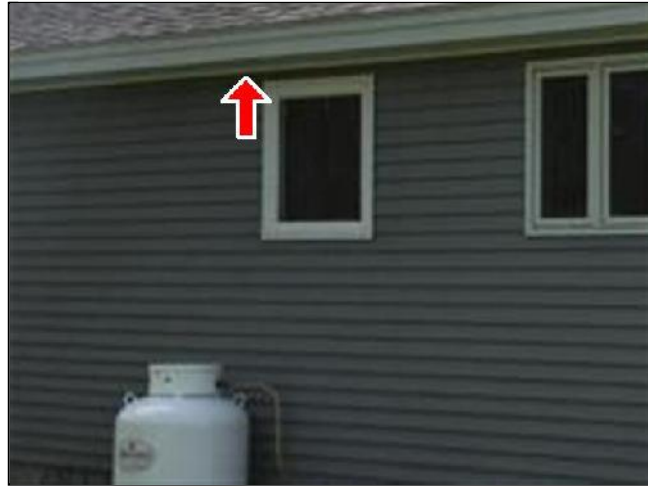
6.6 Exhaust fan not venting to exterior, as required. No vent piping installed and mouth of vent is clogged with insulation. Recommended to vent to exterior, through soffit (not roof). DO NOT vent towards soffit, but vent through soffit for all moist air to exit the attic space.

6.6 Item 1(Picture) Exhaust fan not venting to exterior

6.6 Item 2(Video) Exhaust fan not venting to exterior

6.6 Item 3(Picture) Bath fan not venting to exterior

6.6 Item 4(Picture) Bath vent to exit soffit

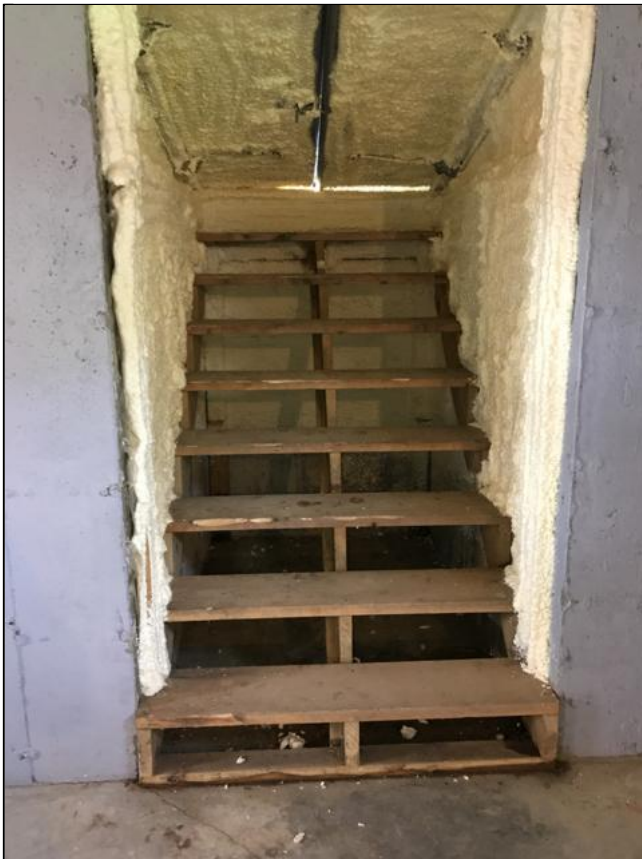
7.0 Door recommended for energy efficiency and to minimize pest intrusion

7.0 Item 1(Picture) Door recommended for energy efficiency

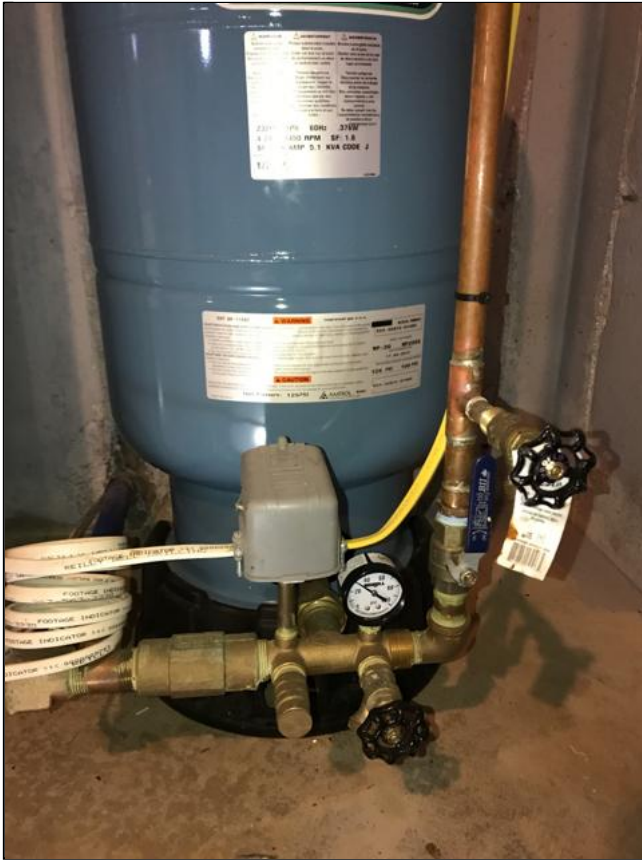
8.1 Item 1(Picture) Well pressure tank

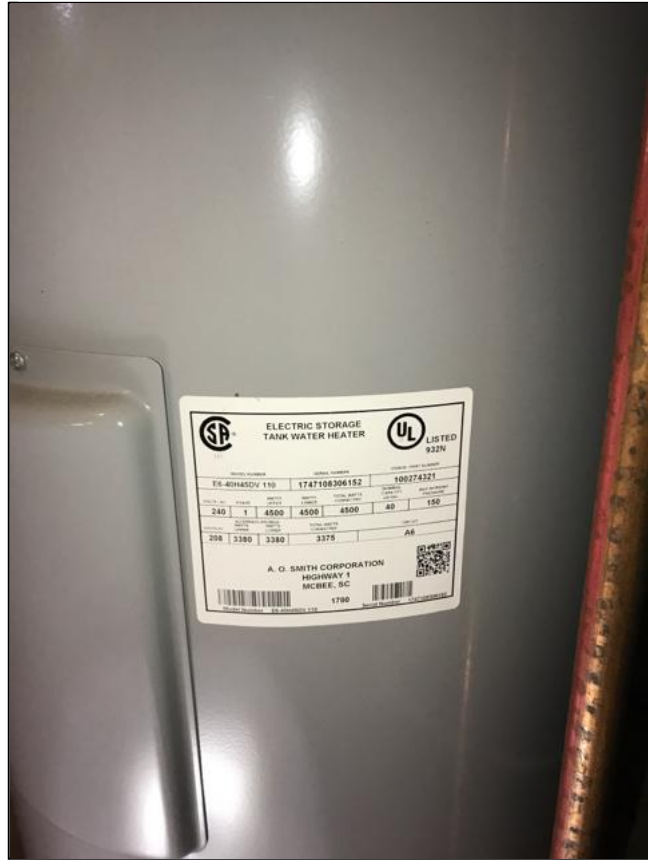
8.1 Metal drain pan recommended per the manufacturer instructions to help collect leaks that may occur and create a barrier between the heater and concrete.

8.1 Item 2(Picture) Water heater detail

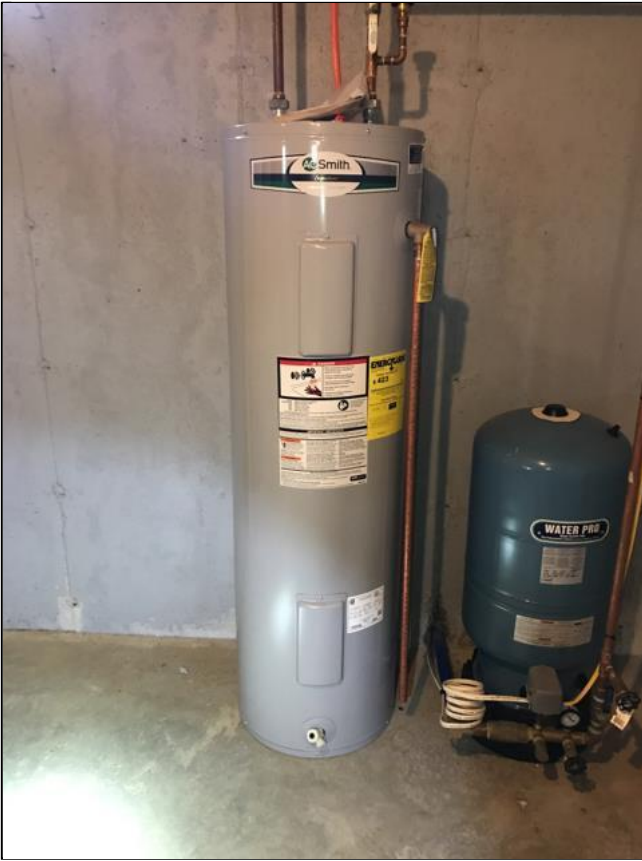
8.2 Metal drain pan recommended beneath water heater, per the manufacturer instructions to help collect leaks that may occur and create a barrier between the heater and concrete.

8.2 Item 1(Picture) Metal drain pan recommended beneath water heater

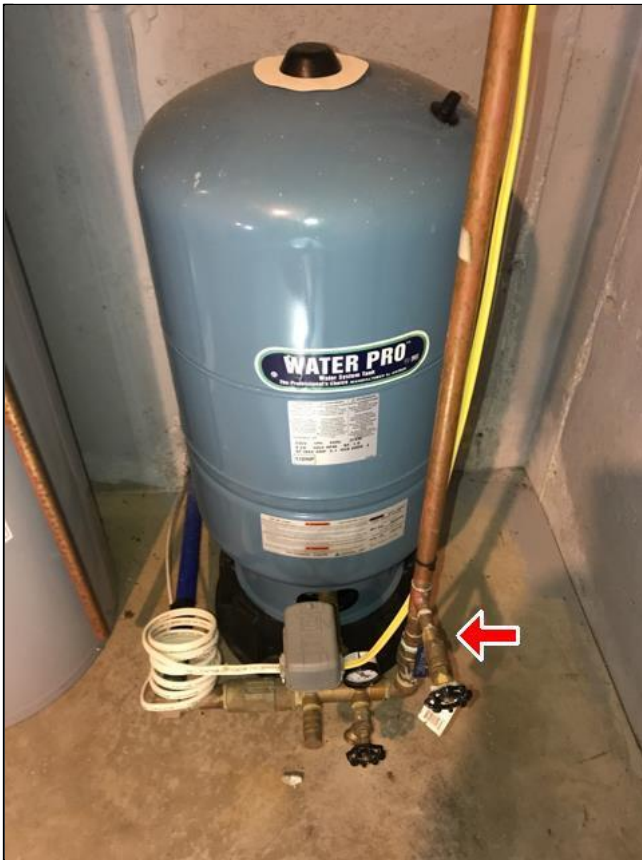
8.3 Water shutoff located near pressure tank

8.3 Item 1(Picture) Water shutoff

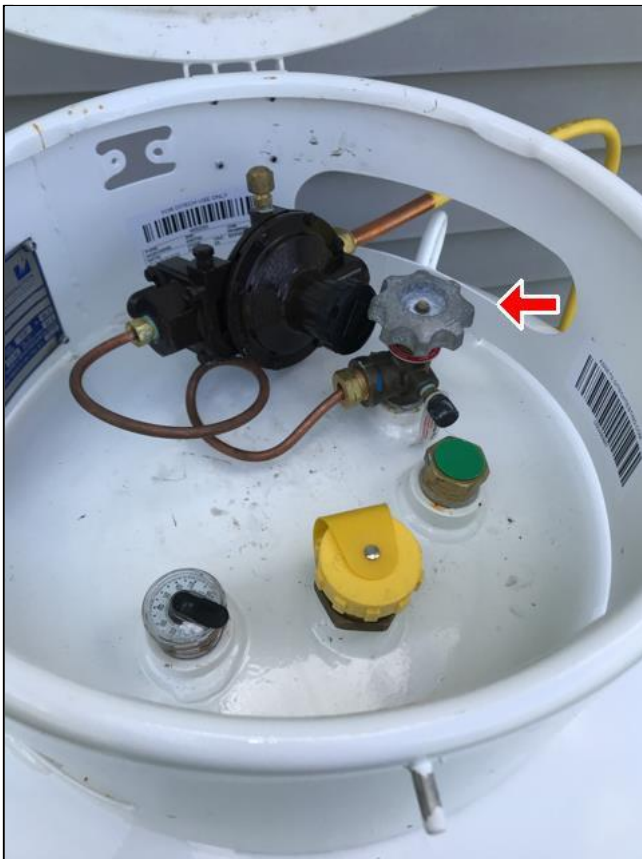
8.5 Fuel shutoff at tank

8.5 Item 1(Picture) Fuel shutoff

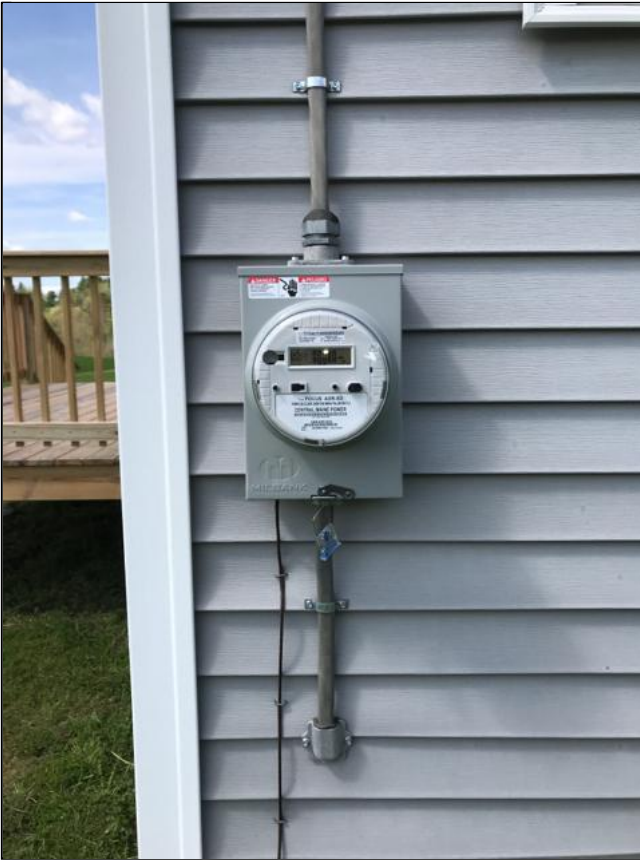
9.0 Meter on exterior of home

9.0 Item 1(Picture) Meter on exterior of home

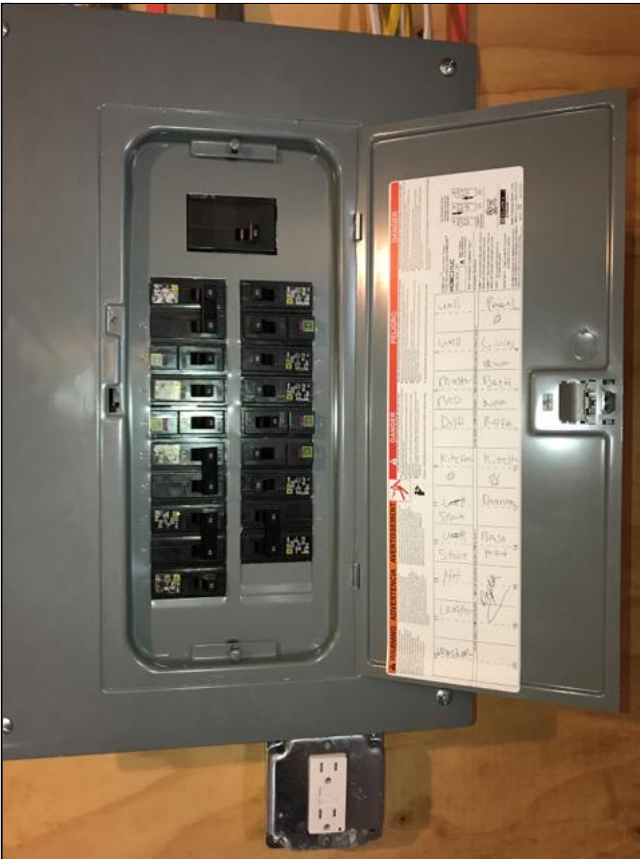
9.1 100 amp panel in basement

9.1 Item 1(Picture) 100 amp panel in basement

9.1 Item 2(Picture) 100 amp panel in basement

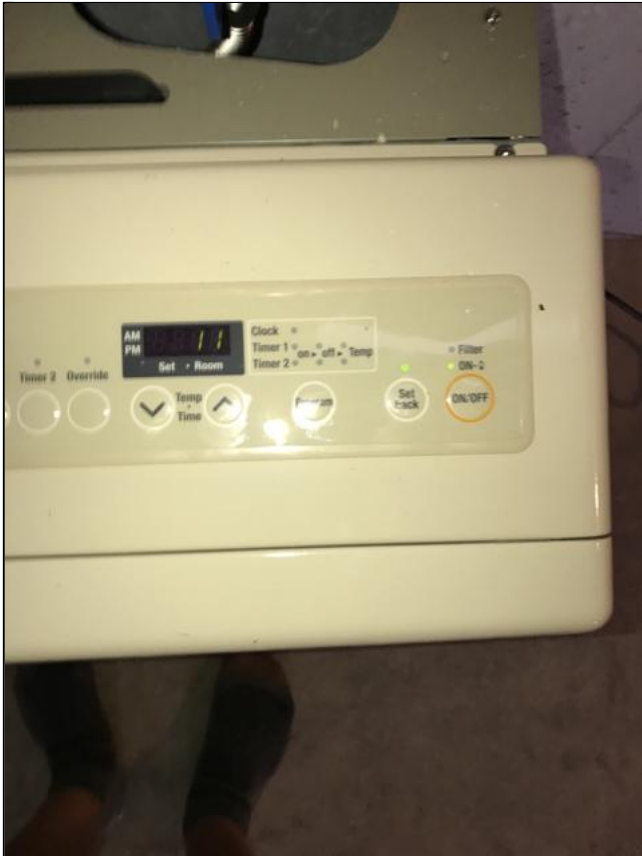
10.0 Error code 11 on each heater. Recommend service by a qualified technician to confirm running properly prior to sale.

10.0 Item 1(Picture) Error code 11 on each heater

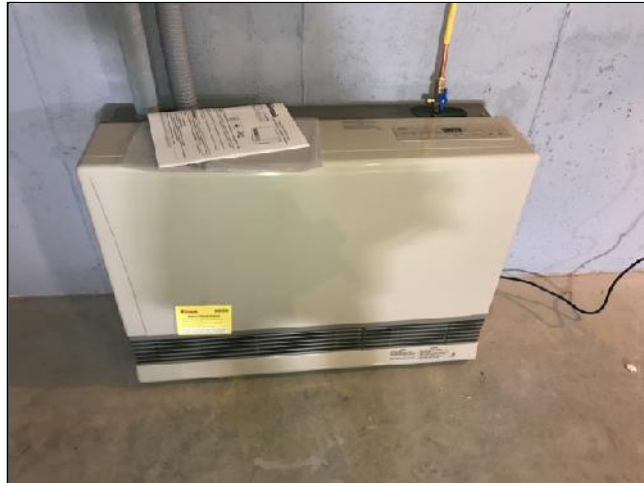
10.0 Item 2(Picture) Rinnai heater in basement and 1st floor

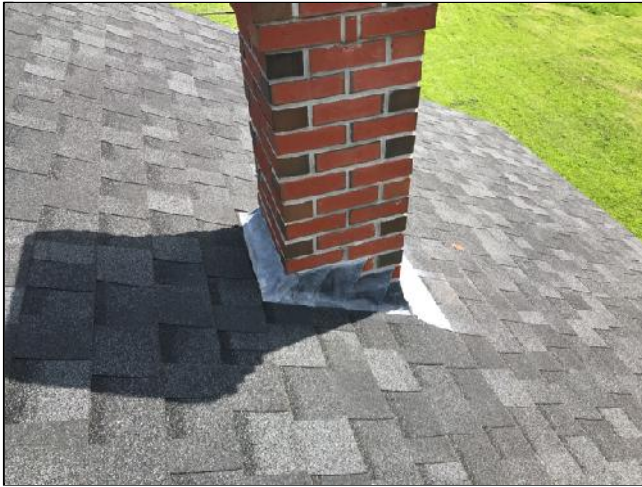
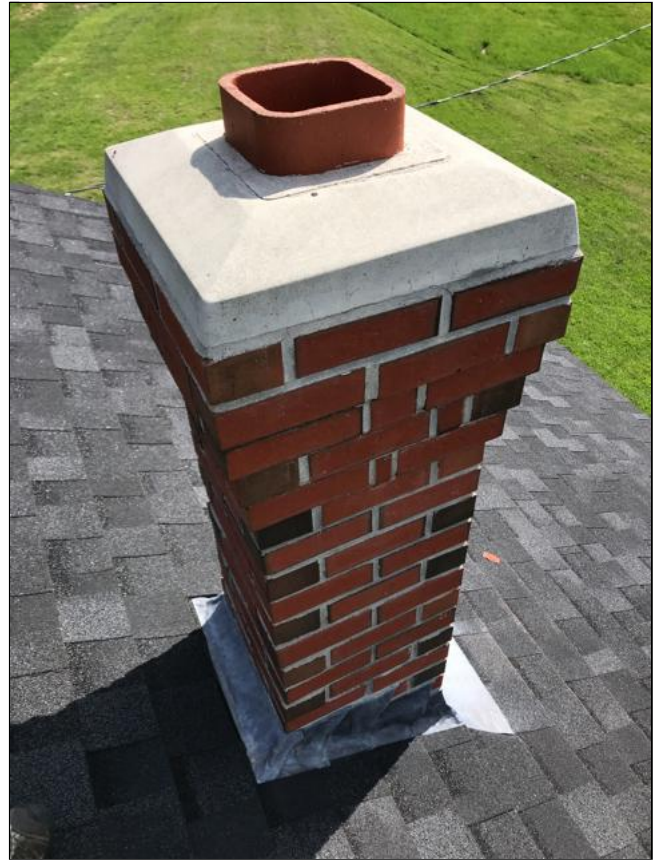
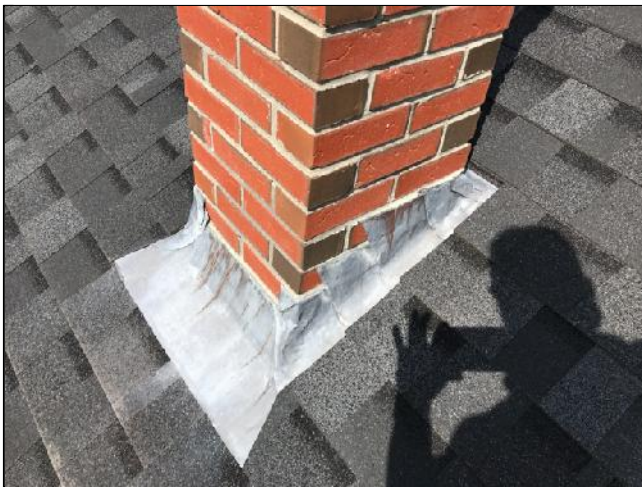
Lead flashing around chimney. Chimney cap is recommended to protect chimney and block rain/snow from entering chimney.

1.2 Item 1(Picture) Lead flashing around chimney

1.2 Item 2(Picture)

1.2 Item 3(Picture) Lead flashing around chimney

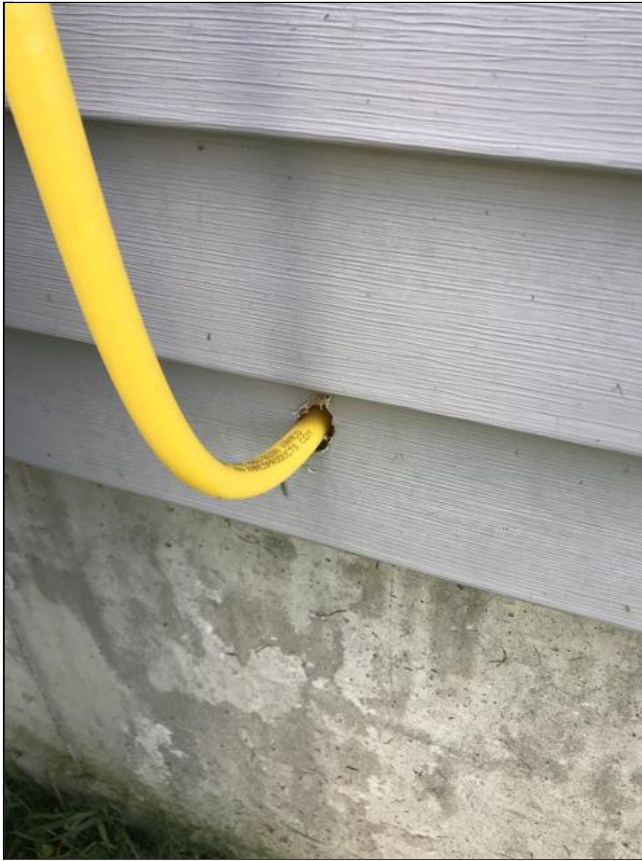
Caulking recommended around fuel entry to block water and pests from entering home

2.0 Item 1(Picture) Caulking recommended

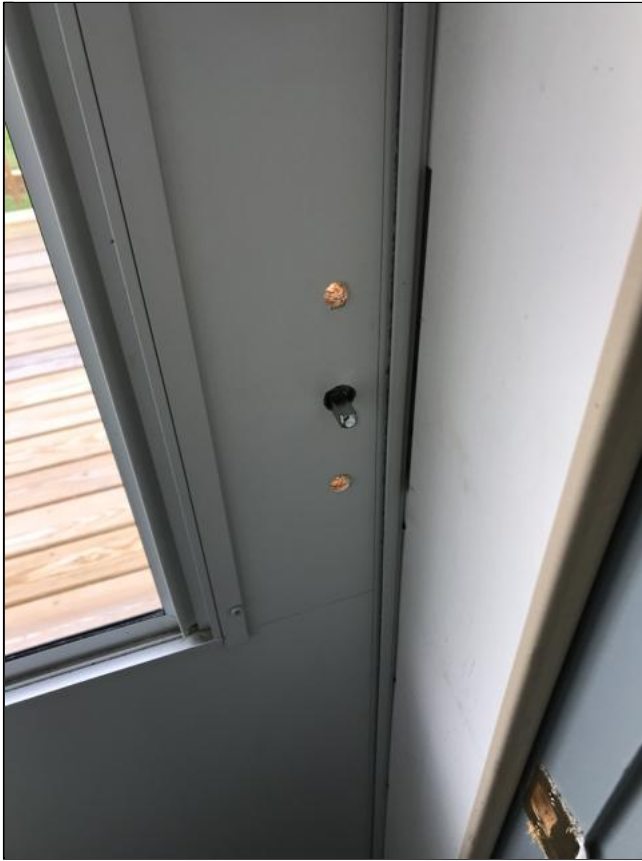
Door to deck is missing doorknob to enter/exit

2.1 Item 1(Picture) Door to deck is missing doorknob to enter/exit

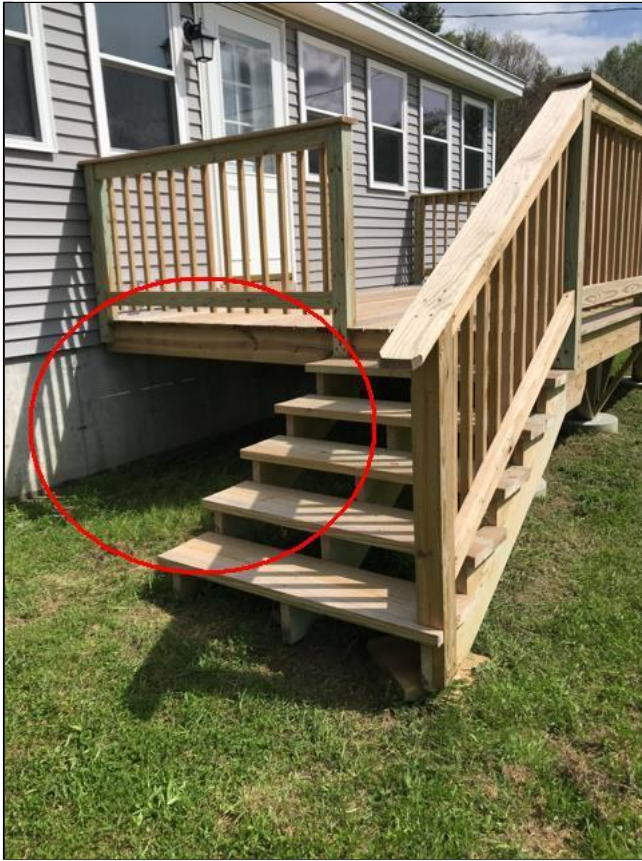
Deck guards are recommended to be added to left side of each staircase, for safety.

2.3 Item 1(Picture) Left side deck guard recommended

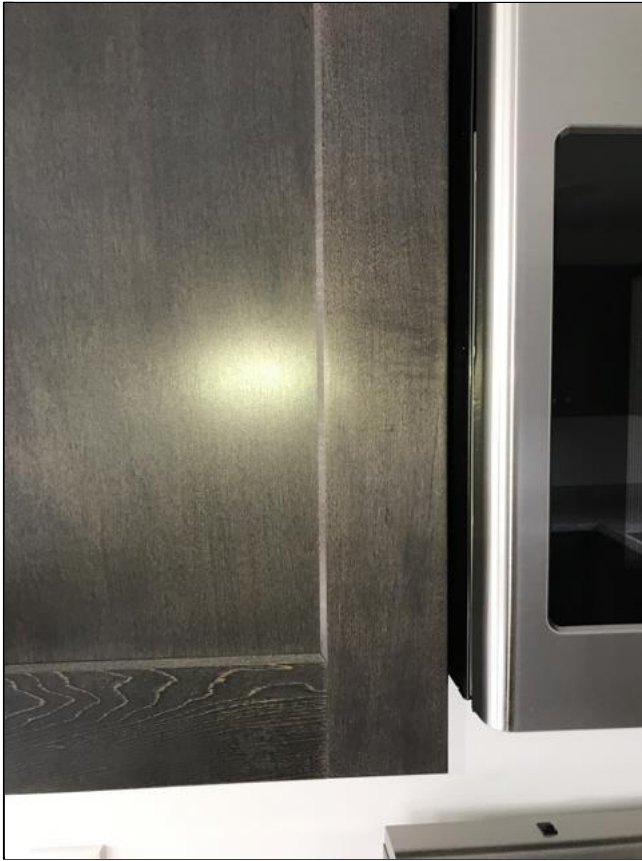
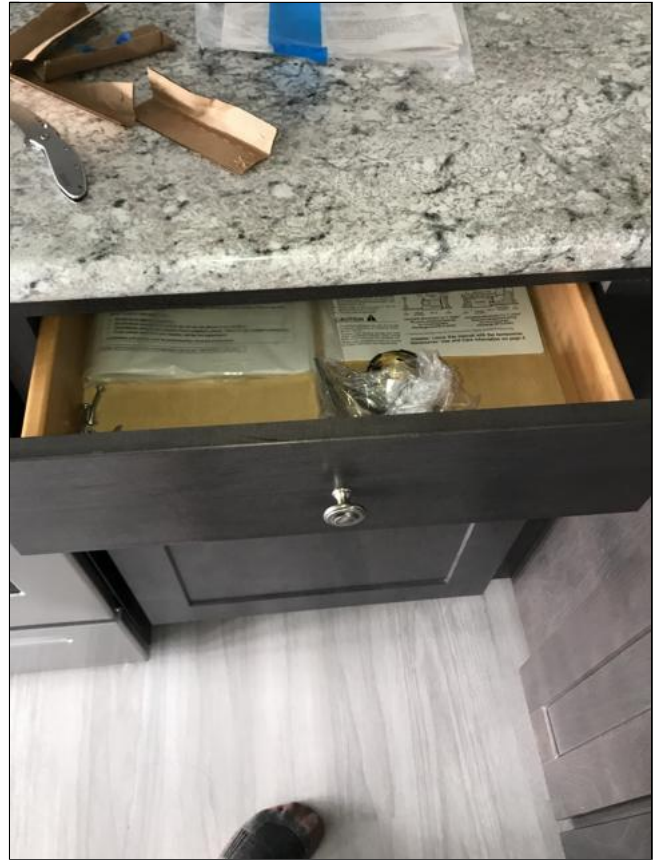
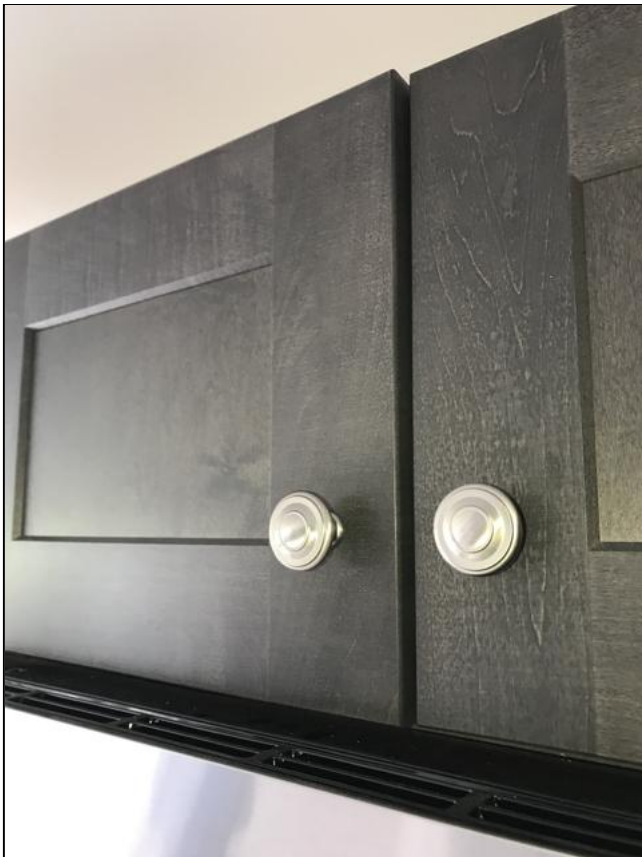
Kitchen cabinets require adjustments.

4.5 Item 1(Picture) Door rubs against microwave

4.5 Item 2(Picture) Drawer does not soft-close as intended

4.5 Item 3(Picture) Door does not close flush
