Inspection Report

Sample Report

123 Main St
Anytown ME 04000

Square One Home Inspections LLC

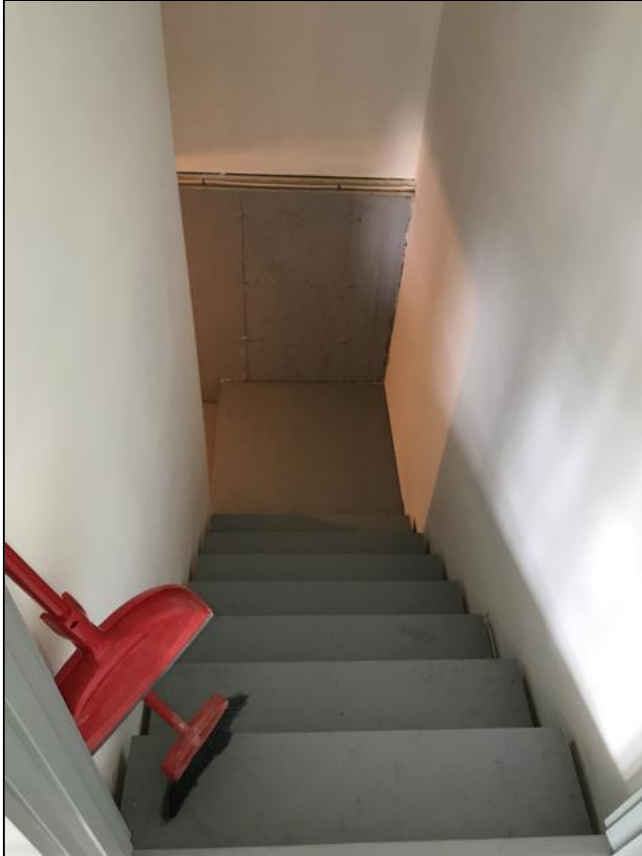
Railing required on at least one side of stairs

5.3 Item 1(Picture) Railing required on at least one side of stairs

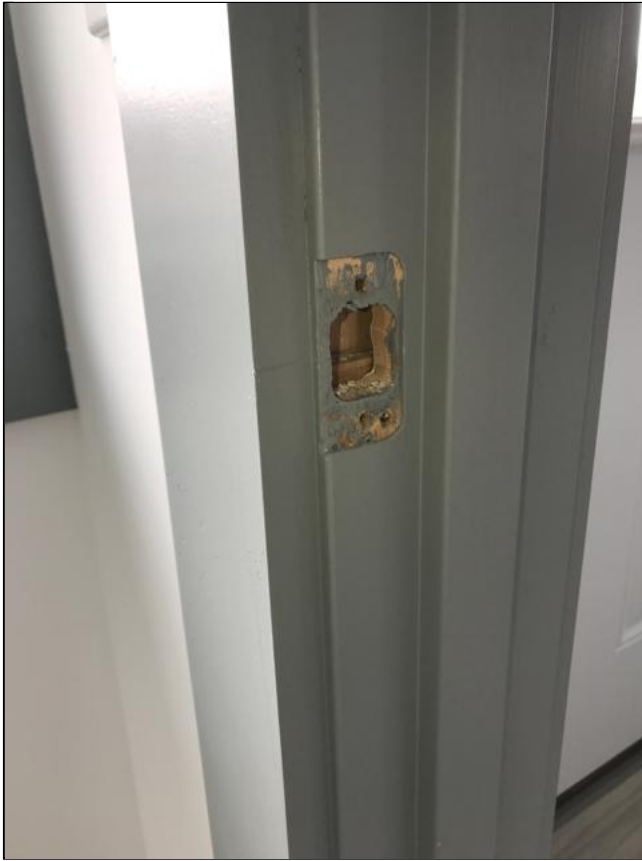
Door slide/guide is missing in front office/bedroom

5.4 Item 1(Picture) Door slide/guide is missing in front office/bedroom

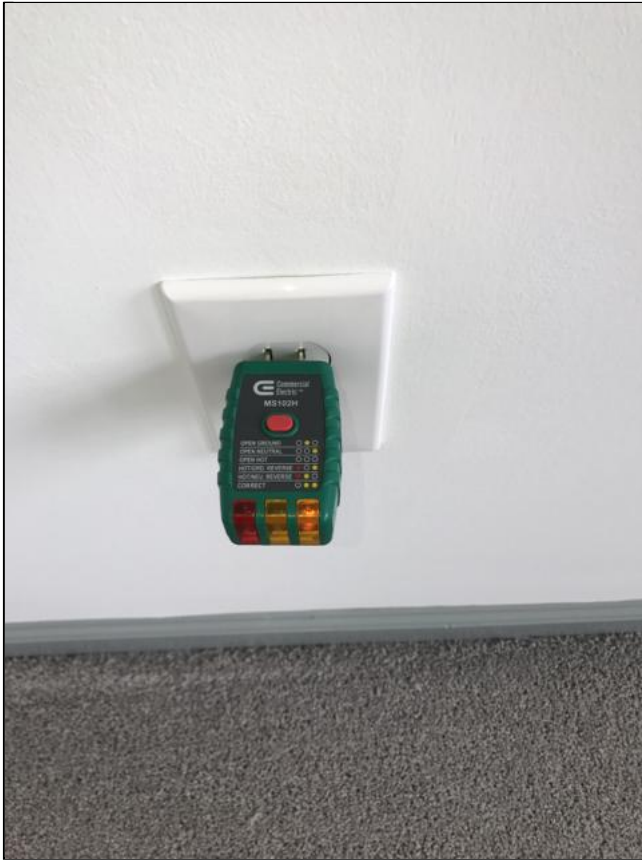
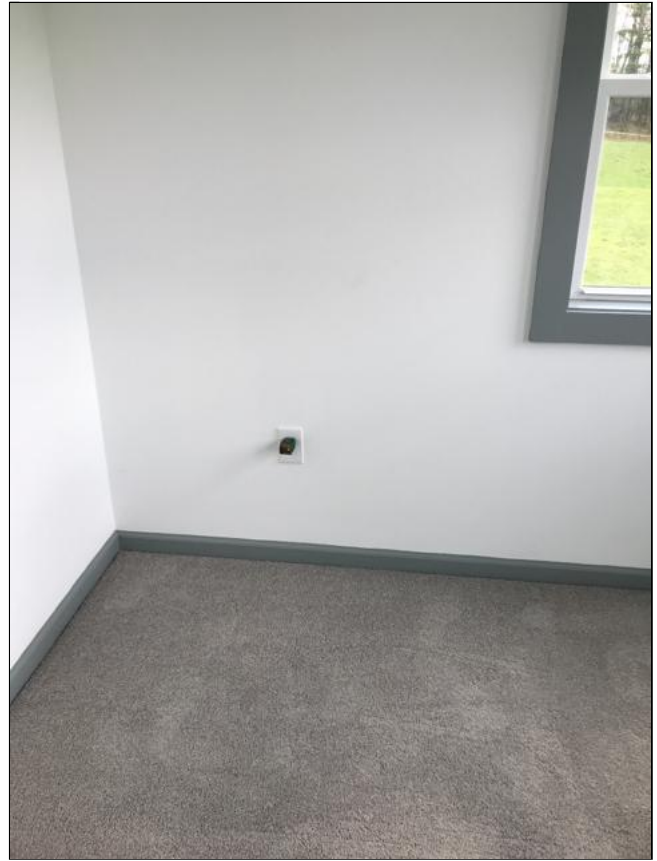
Front office/bedroom outlet incorrectly installed with an open neutral. Recommend to be re-installed by a qualified electrician.

5.6 Item 1(Picture) Receptacle incorrectly installed

5.6 Item 2(Picture) Receptacle incorrectly installed

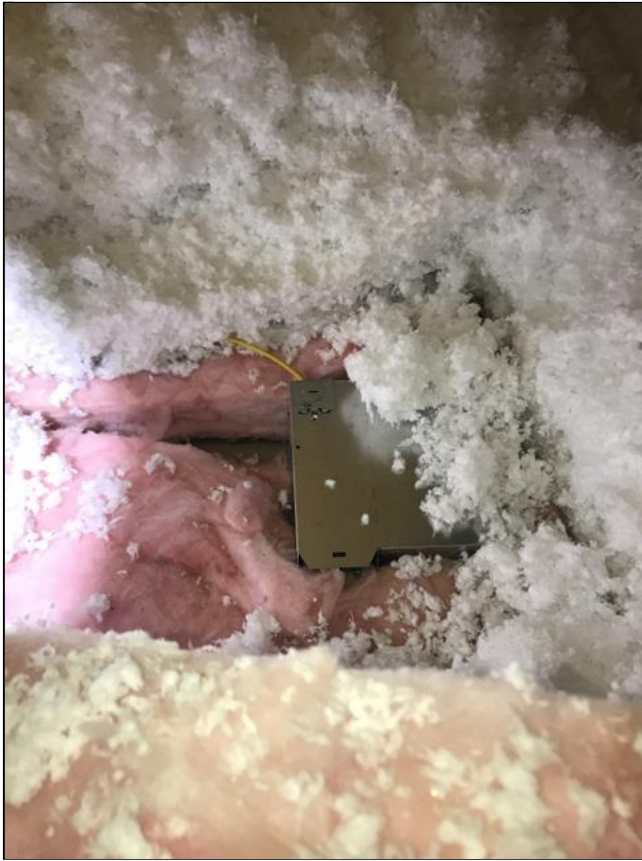
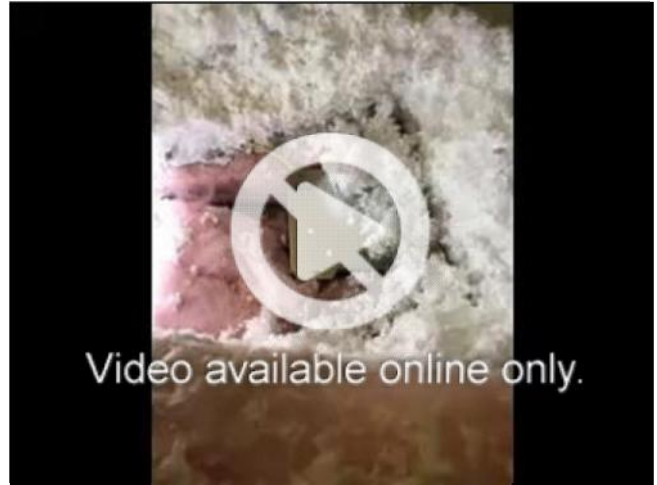
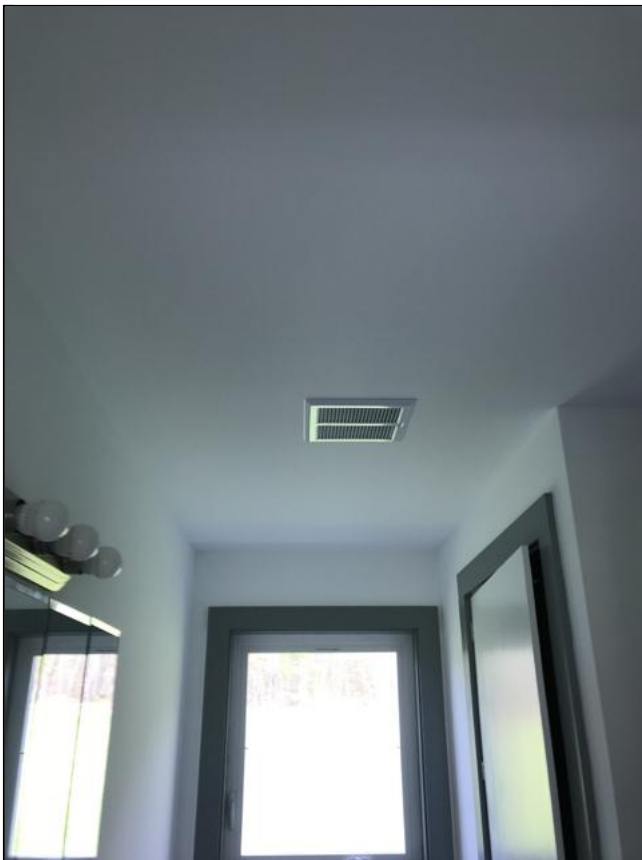
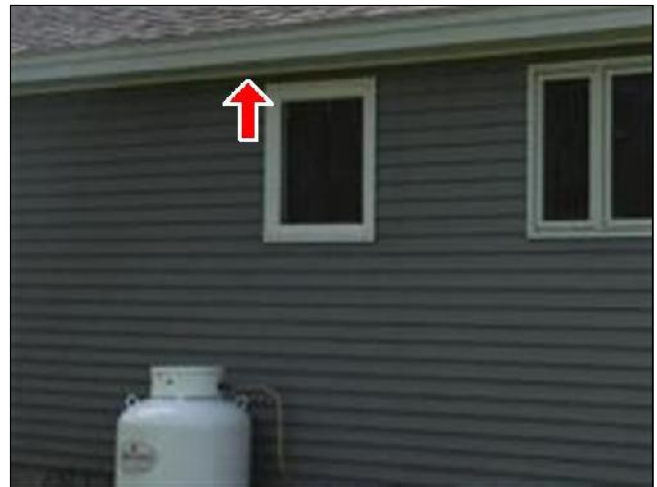
Exhaust fan not venting to exterior, as required. No vent piping installed and mouth of vent is clogged with insulation. Recommended to vent to exterior, through soffit (not roof). DO NOT vent towards soffit, but vent through soffit for all moist air to exit the attic space.

6.6 Item 1(Picture) Exhaust fan not venting to exterior

6.6 Item 2(Video) Exhaust fan not venting to exterior

6.6 Item 3(Picture) Bath fan not venting to exterior

6.6 Item 4(Picture) Bath vent to exit soffit

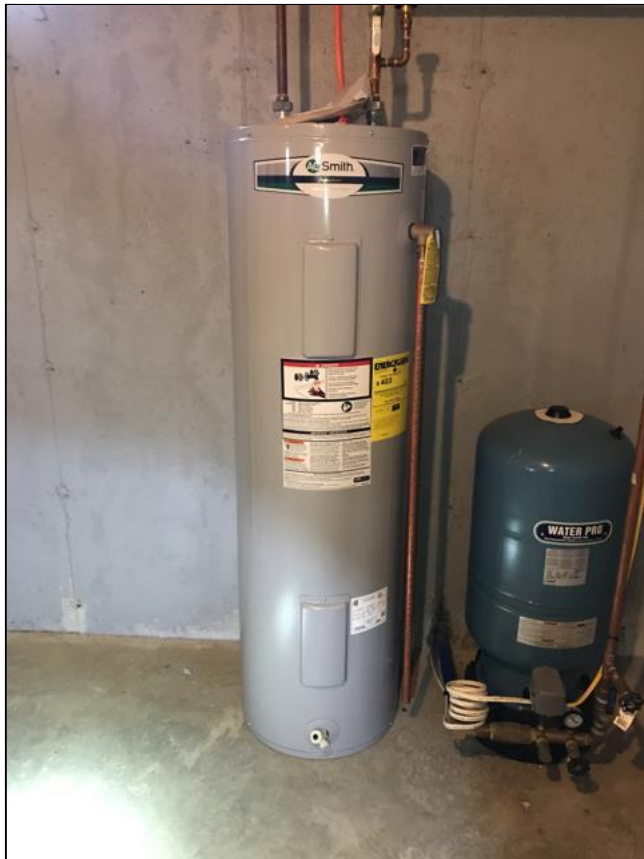
Metal drain pan recommended beneath water heater, per the manufacturer instructions to help collect leaks that may occur and create a barrier between the heater and concrete.

8.2 Item 1(Picture) Metal drain pain recommended beneath water heater

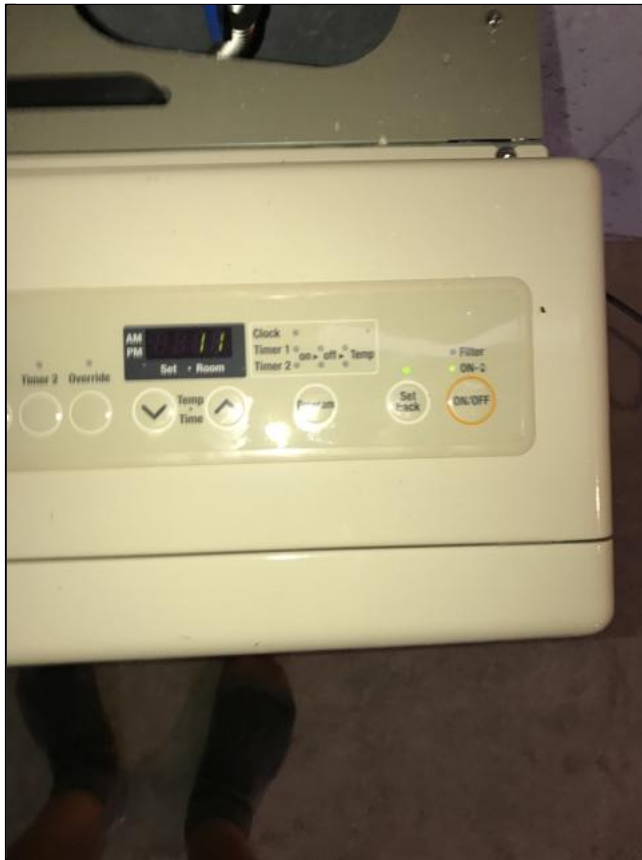
Error code 11 on each heater. Recommend service by a qualified technician to confirm running properly prior to sale.

10.0 Item 1(Picture) Error code 11 on each heater
